Investigation of Corrosion on Inland Petroleum Distribution System Aluminum Pipe Grooved Ends Caused by Rubber Gaskets

ARL-TR-1449

August 1997

Weapons and Materials Research Directorate, ARL

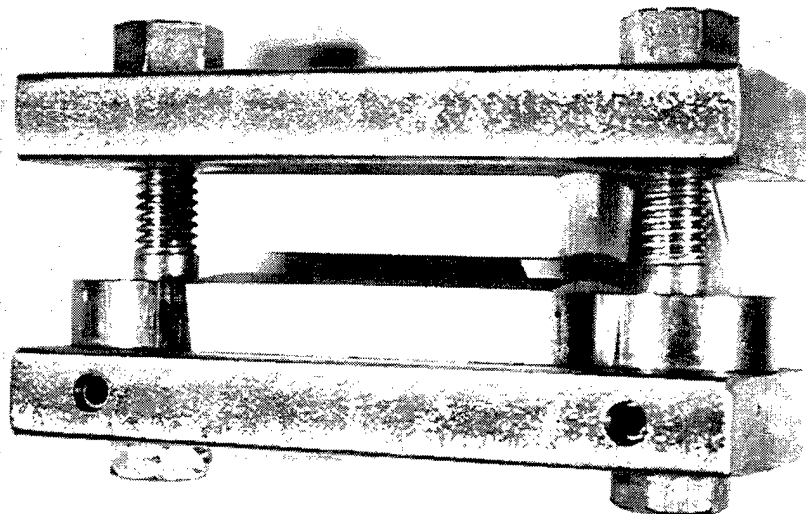
Figure 4. View of the flat rubber specimen placed between two small, curved aluminum pipe pieces in the stainless steel clamp for the accelerated corrosion test (actual size). The specimen is in contact with both bare aluminum surfaces.
